# Little Things

*A pinhole in a copper line, and a ceiling that told on it months later.*

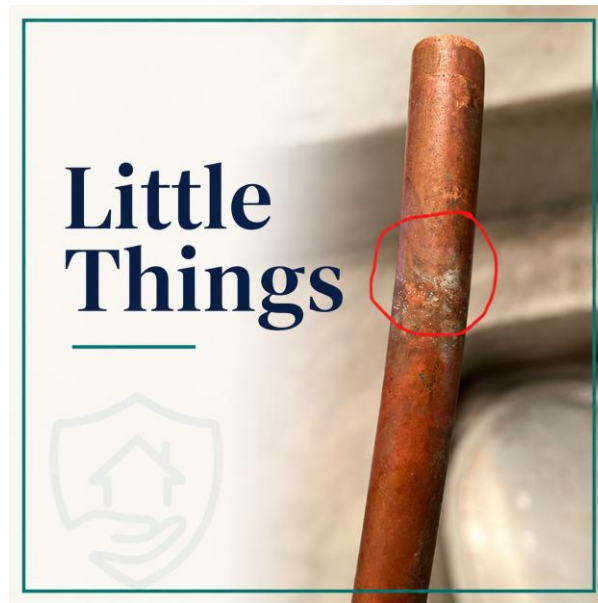
The evidence suggests the leak likely originated from a pinhole failure in the copper refrigerant or condensate piping associated with the attic HVAC system. Pinhole leaks in copper tubing most commonly develop from long-term corrosion rather than a sudden failure. Factors such as formicary corrosion (sometimes called “ant’s nest” corrosion), manufacturing defects, vibration where the tubing rubs against framing, exposure to acidic building materials, or prolonged moisture can slowly thin the copper until a microscopic hole develops. Because these openings are extremely small, they often release only a tiny amount of water over an extended period, making the problem difficult to detect during its early stages.

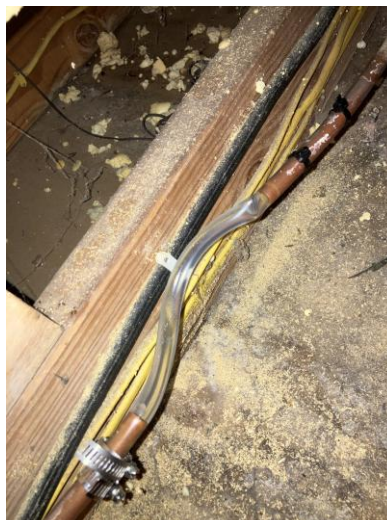
*The attic line above the closet after temporary repair*

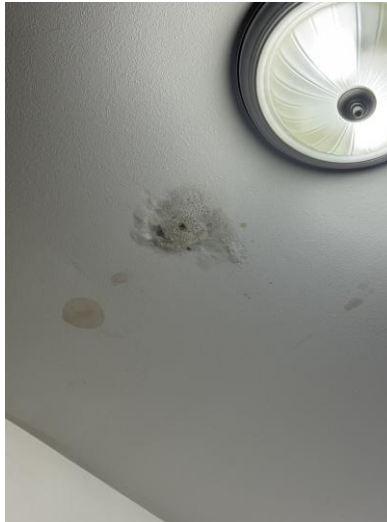
The staining and visible mold growth on the closet ceiling indicate that moisture was likely present for an extended period rather than resulting from a single leak event. Small, continuous leaks frequently allow moisture to wick into drywall insulation and surrounding building materials, where it remains trapped. Over time, repeated wetting and drying cycles create the ideal environment for staining, mildew, and mold growth, often producing multiple water spots as moisture migrates through the drywall before finally becoming visible on the finished ceiling surface. By the time staining appears inside the living space, the leak has often been active far longer than most homeowners realize.

*The closet ceiling : the first thing anyone actually saw.*

While it is impossible to determine an exact timeline without opening the ceiling and inspecting the HVAC system, damage of this nature commonly develops over a period of several months and, in many cases, can continue unnoticed for a year or more. A pinhole leak may release only a few drops at a time, but over thousands of HVAC operating cycles those small amounts accumulate into significant moisture intrusion. Routine attic inspections and seasonal HVAC maintenance often identify these types of issues before interior damage becomes visible, underscoring why small maintenance items can prevent much larger and more expensive repairs.

In this particular case, the damage appears to be surface only, with no ducts containing mold, though in South Louisiana, that's never a perfectly accurate statement. A thorough cleaning of the ceiling (bleach), sealing the water spots, and repainting this ceiling has it looking like new, but only after having allowed the repair to "prove" that's the only issue.
